City of Chicopee

RE: City Council Minutes from the May 27, 2016 Special Meeting

Dietz and Company Architects, Inc. is pleased to present this Historic Structure Report (HSR) and the results of the team's efforts to document the history and physical condition of Chicopee City Hall. The overall purpose of any Historic Structure Report is to guide future rehabilitation, restoration, and preservation work for the subject structure. The 'Historical Information' section documents the history of the building and its changes over time. The 'System Description and Observations' portion of the report summarizes the survey, analysis and recommendations for the building.

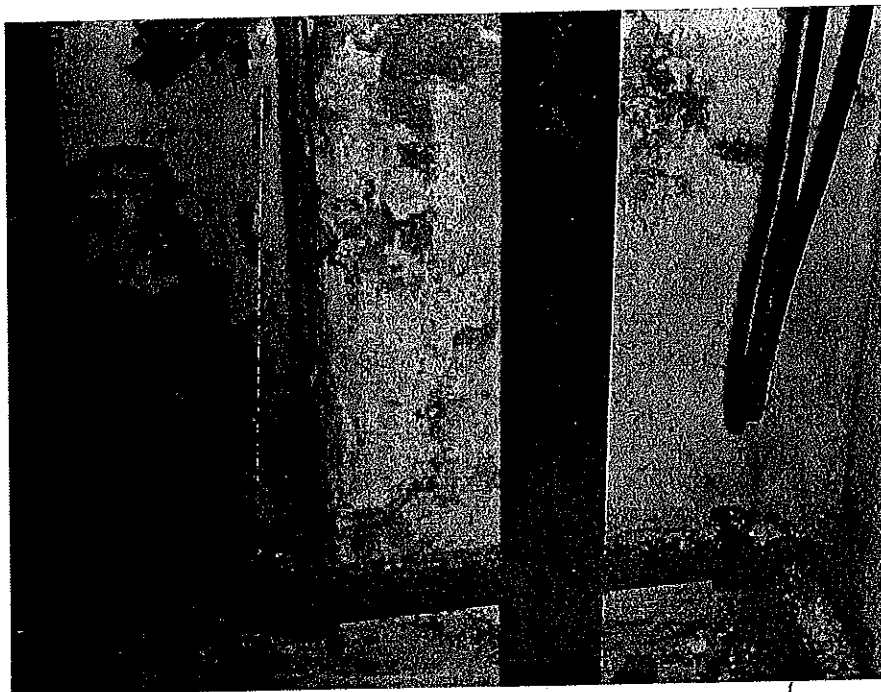
S10. Interior northwest corner.

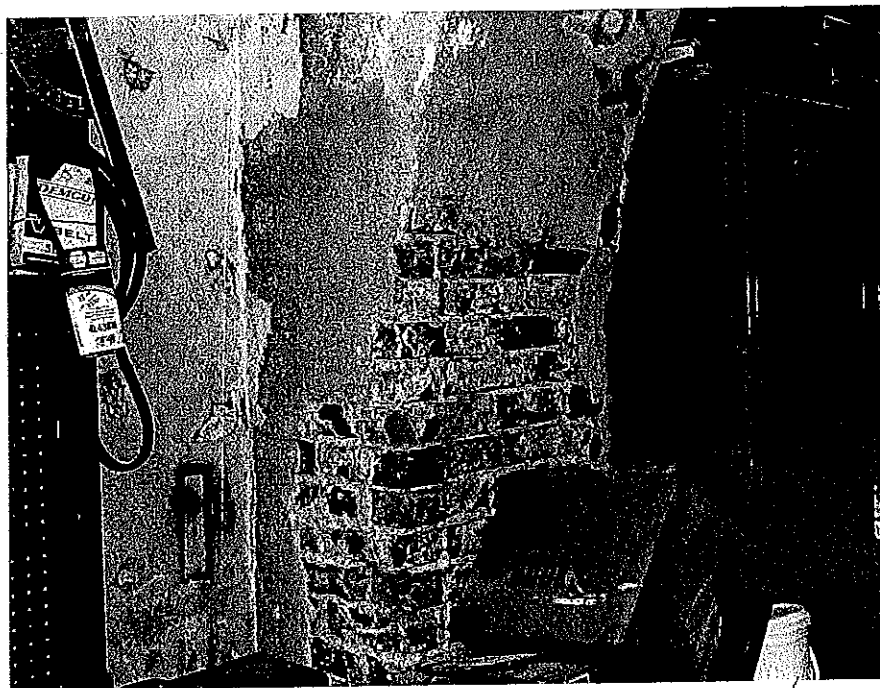
S12. Interior arch northwest corner, deteriorated brick arch.

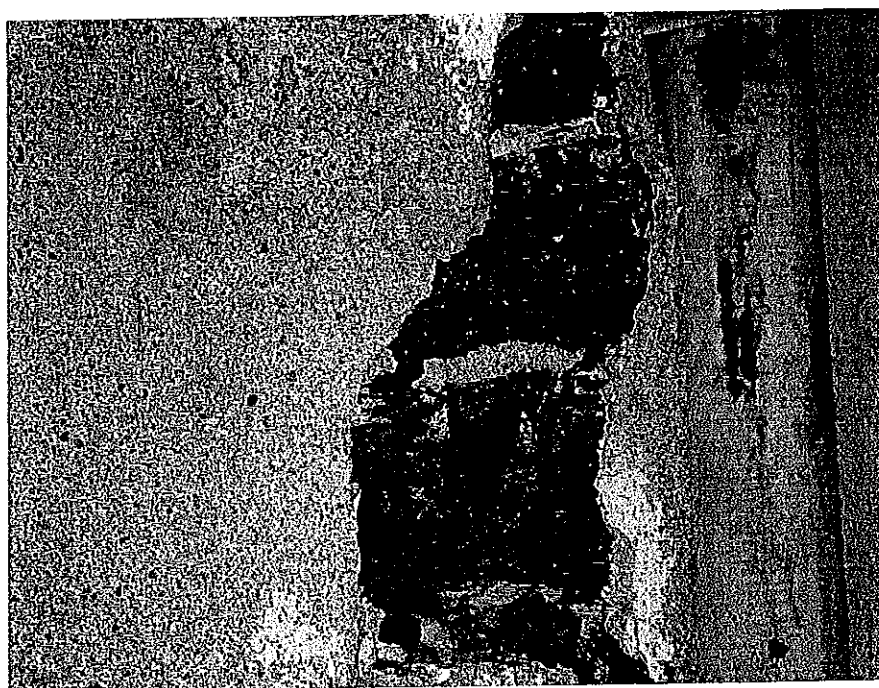
S13. Interior arch northwest corner, deteriorated brick arch.

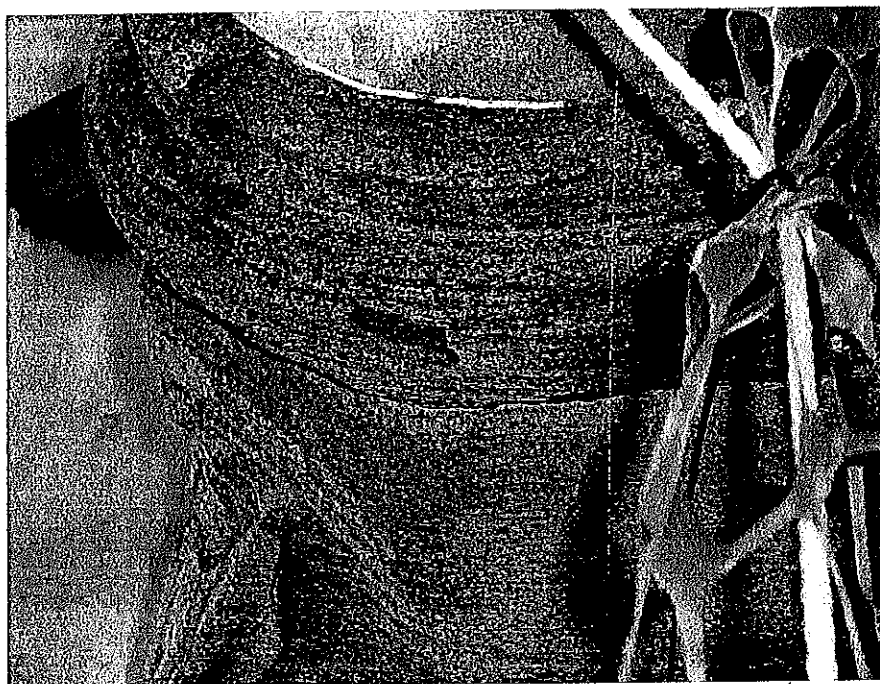
S14. West elevation s column base badly deteriorated.

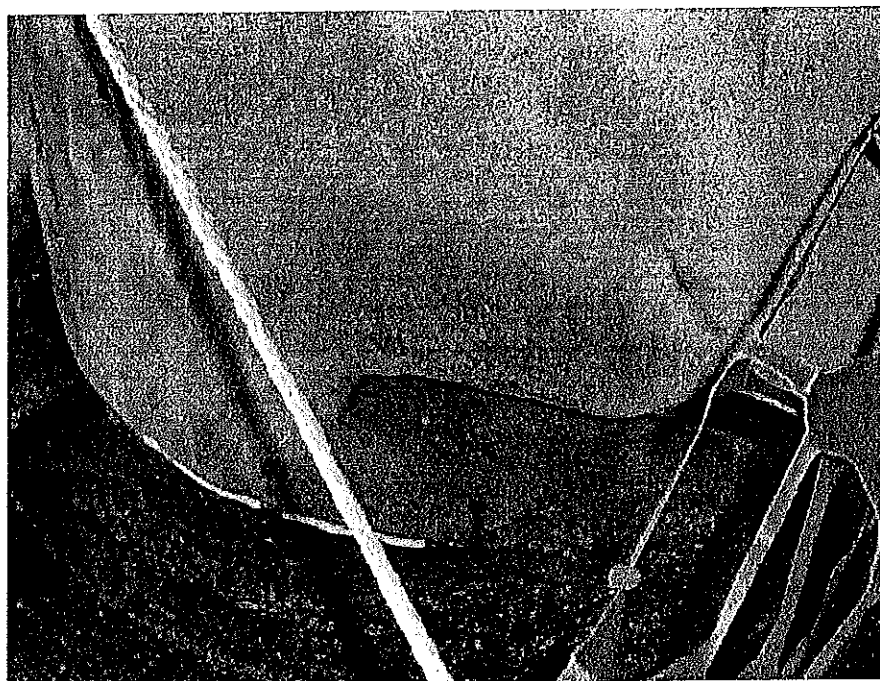
S15. West elevation sandstone column base badly deteriorated.

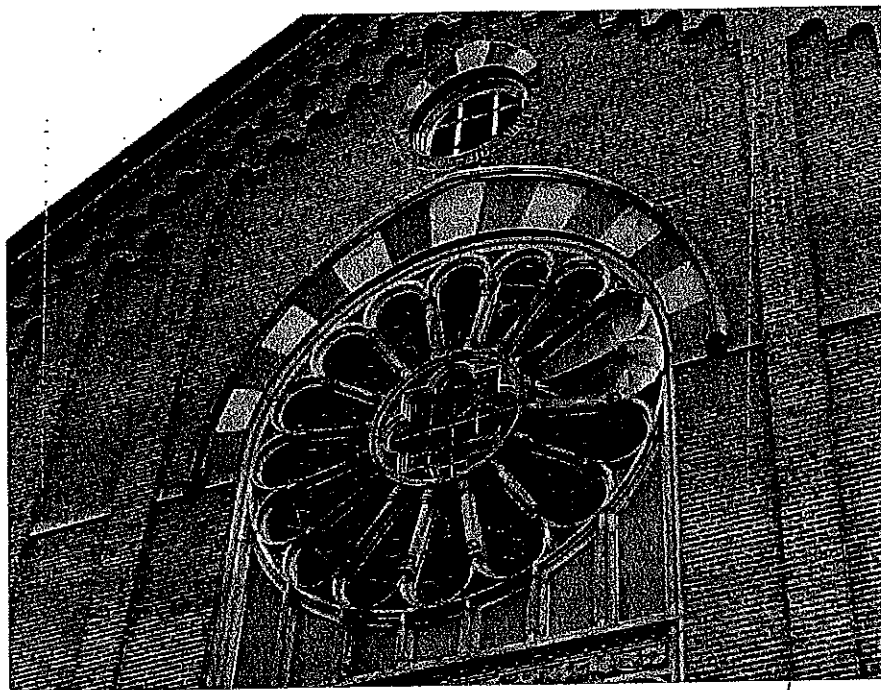
S17. West elevation, exterior stone arch over Rose Window.

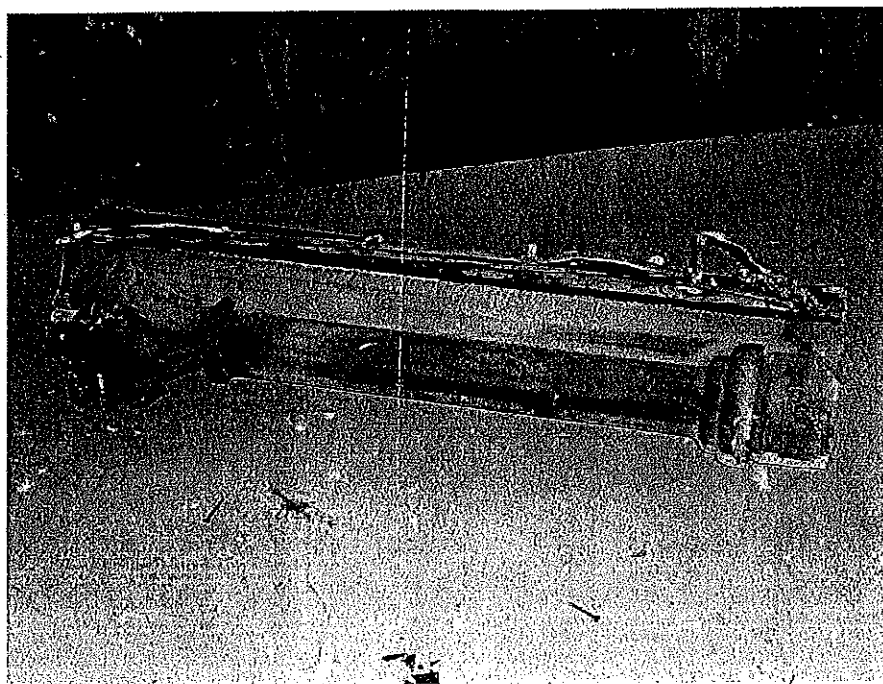
S21. Broken stone tracery from Rose Window.

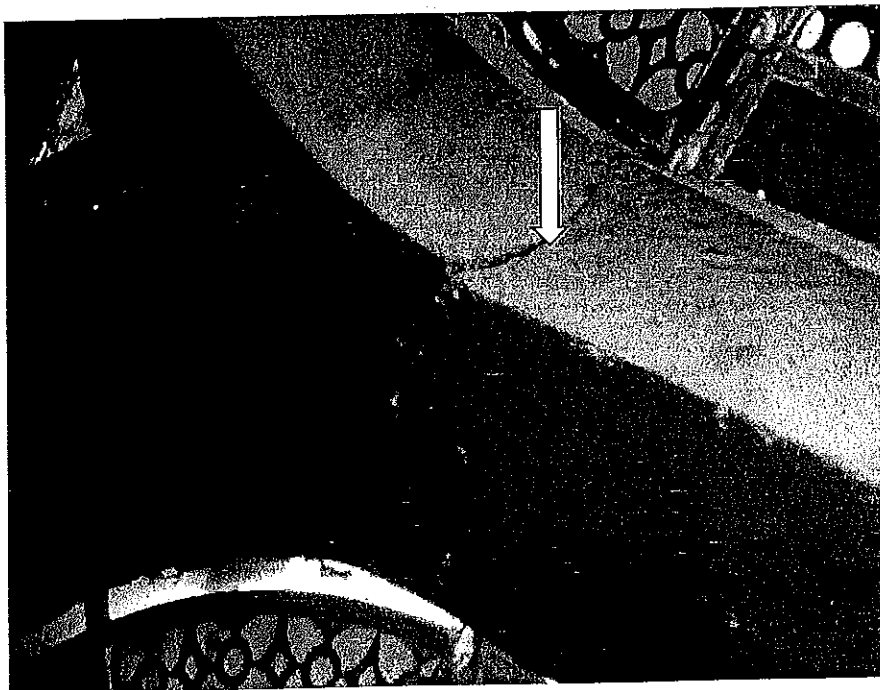
S24. Broken stone tracery at Rose Window.

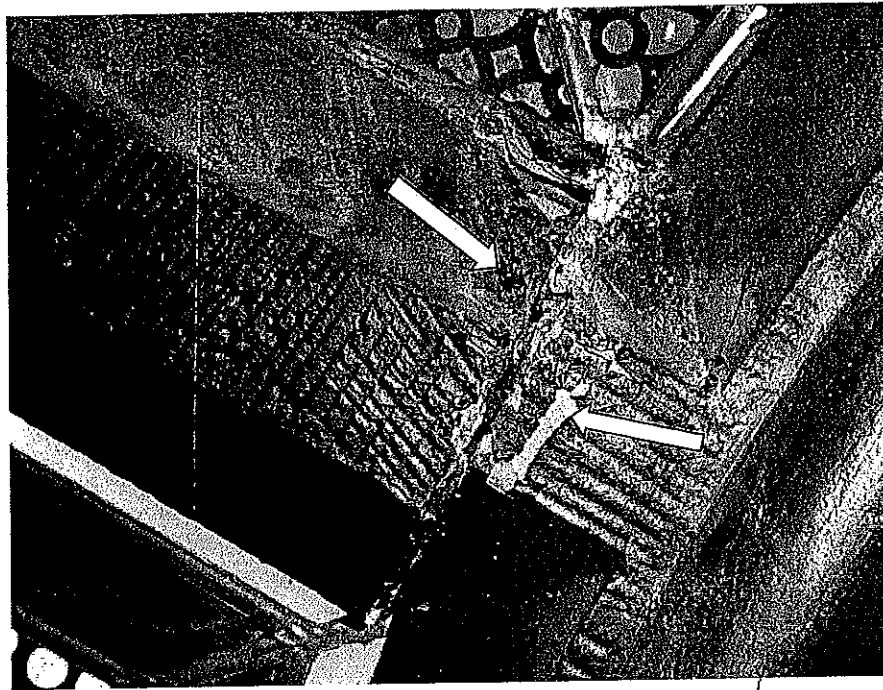
S25. Broken stone tracery at Rose Window.

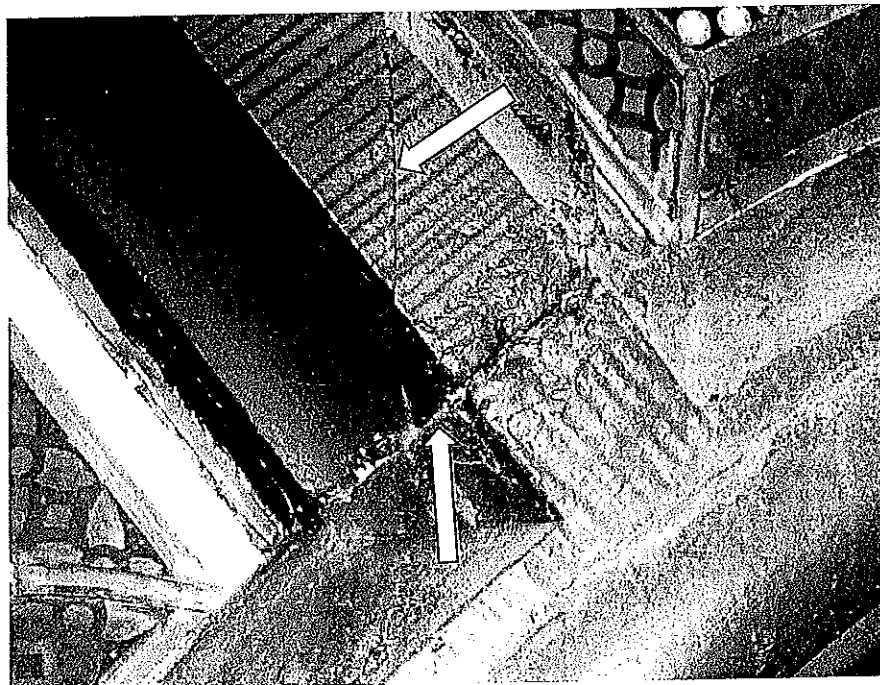
S26. Broken stone tracery at Rose Window.

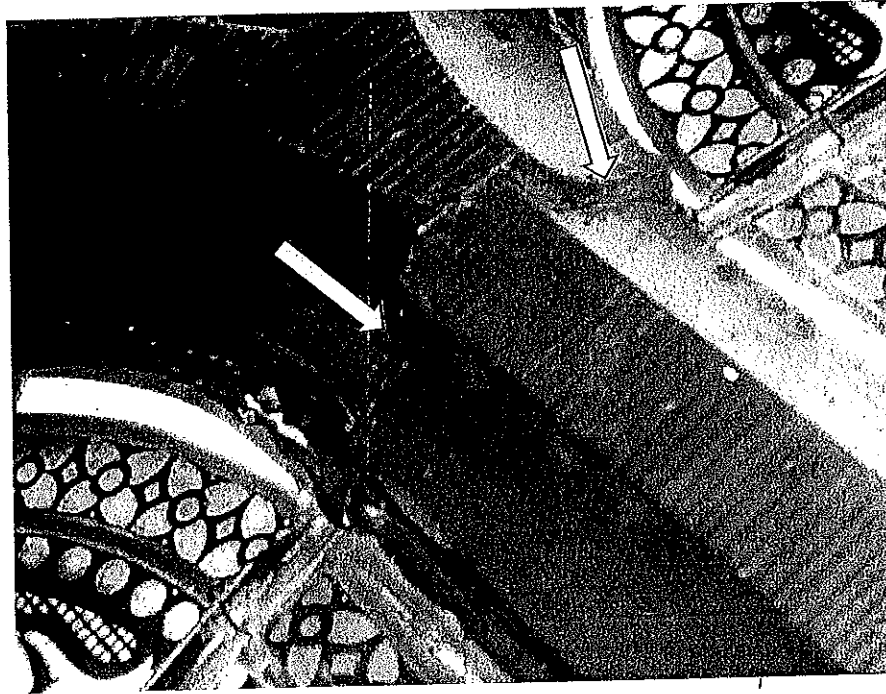
S27. Broken stone tracery at Rose Window.

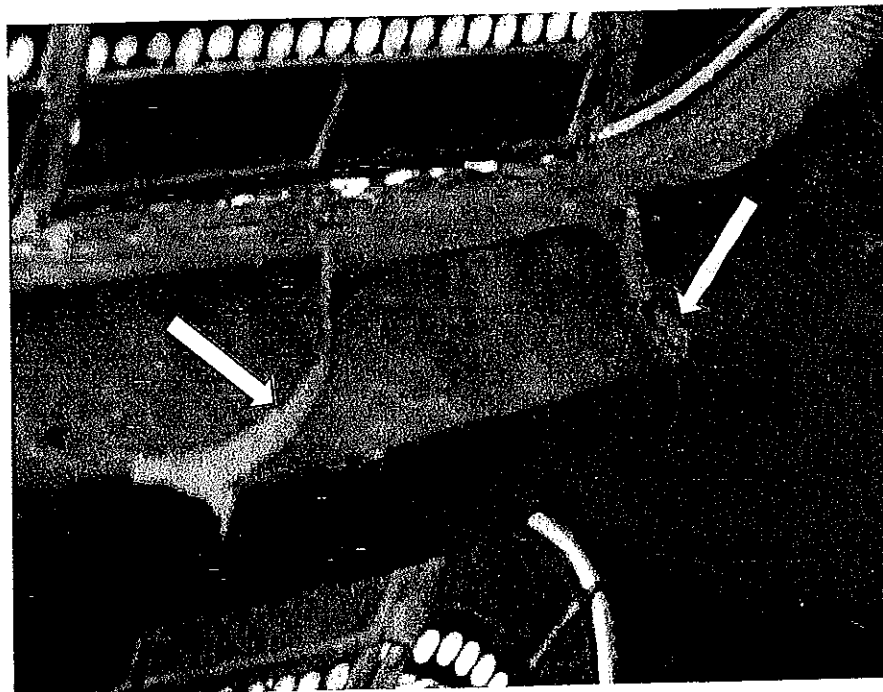
S28. Broken stone tracery at Rose Window.

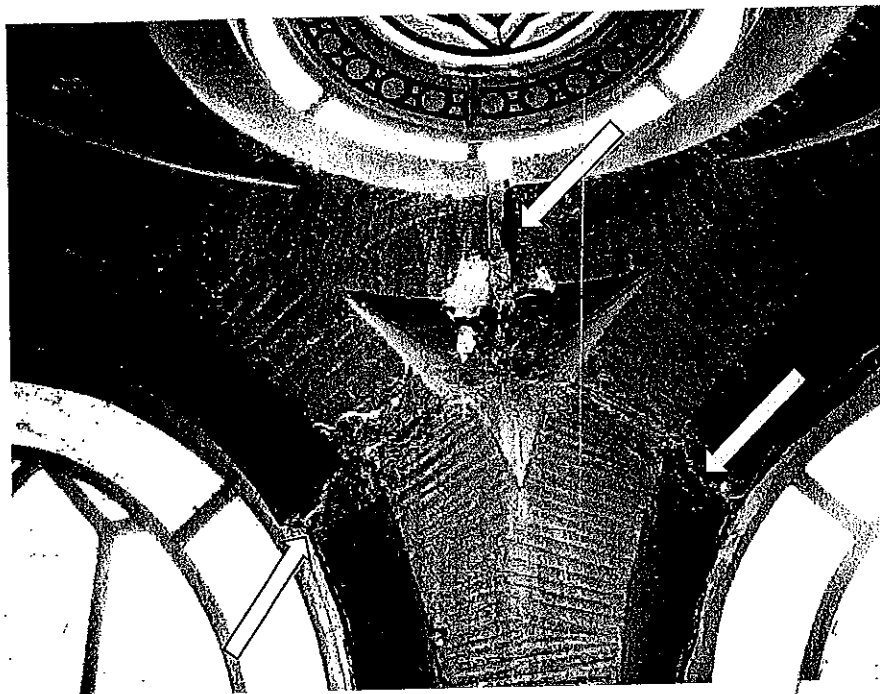
S29. Broken stone tracery at window to left of Rose Window.

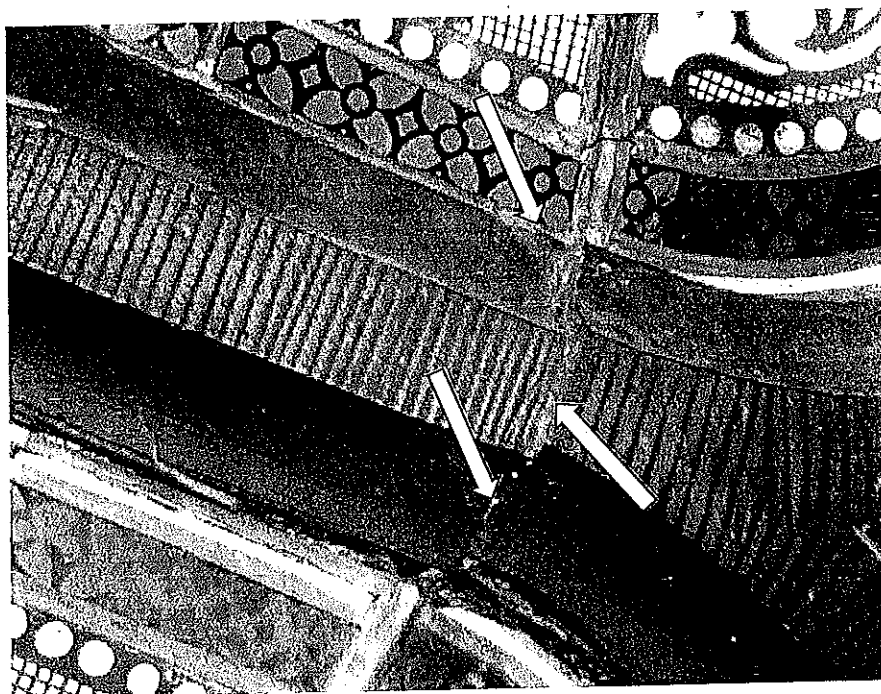
S30. Broken stone tracery at window to left of Rose Window.

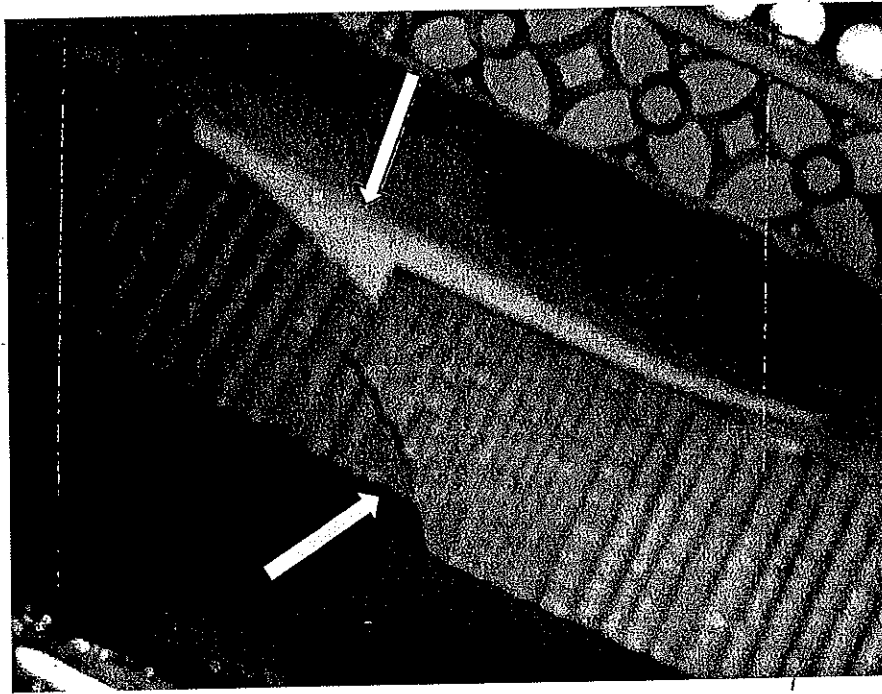
S31. Broken stone tracery at window to left of Rose Window.

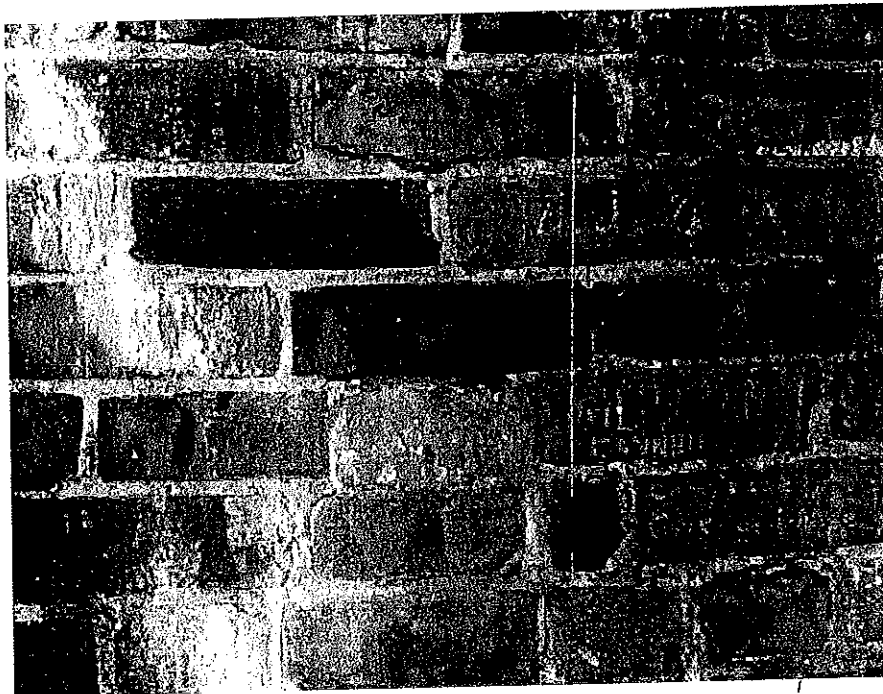
S45. Poor quality brickwork and deteriorated mortar joints at interior of Clock Tower.

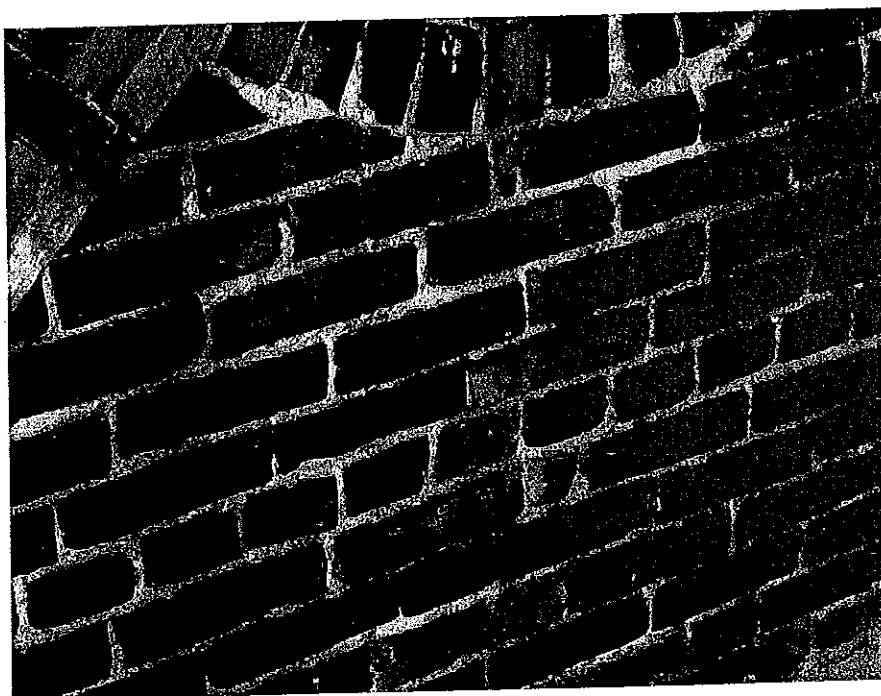
S46. Poor quality brickwork and deteriorated mortar joints at interior of Clock Tower.

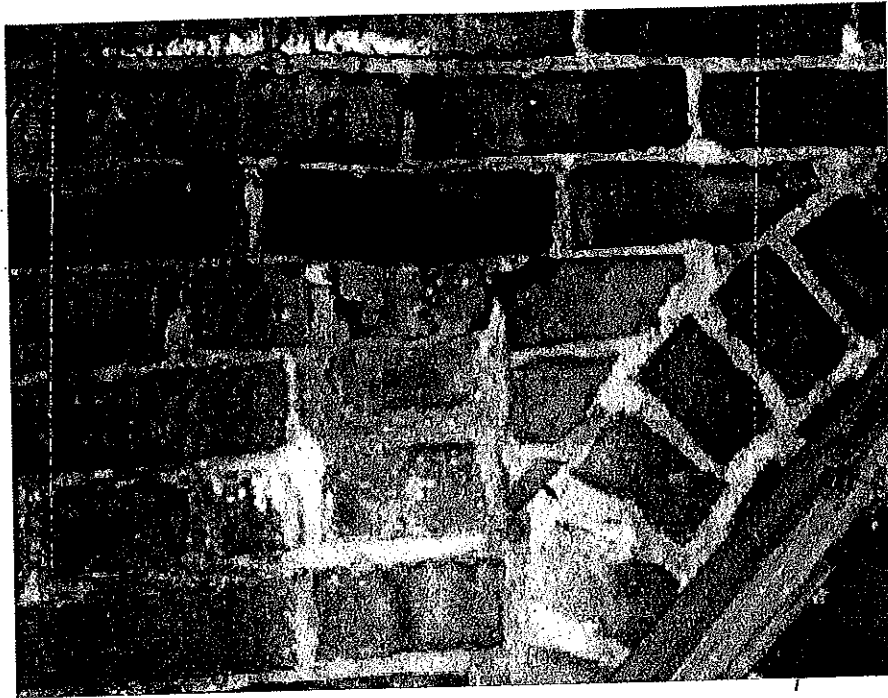
S47. Poor quality brickwork and deteriorated mortar joints at interior of Clock Tower.

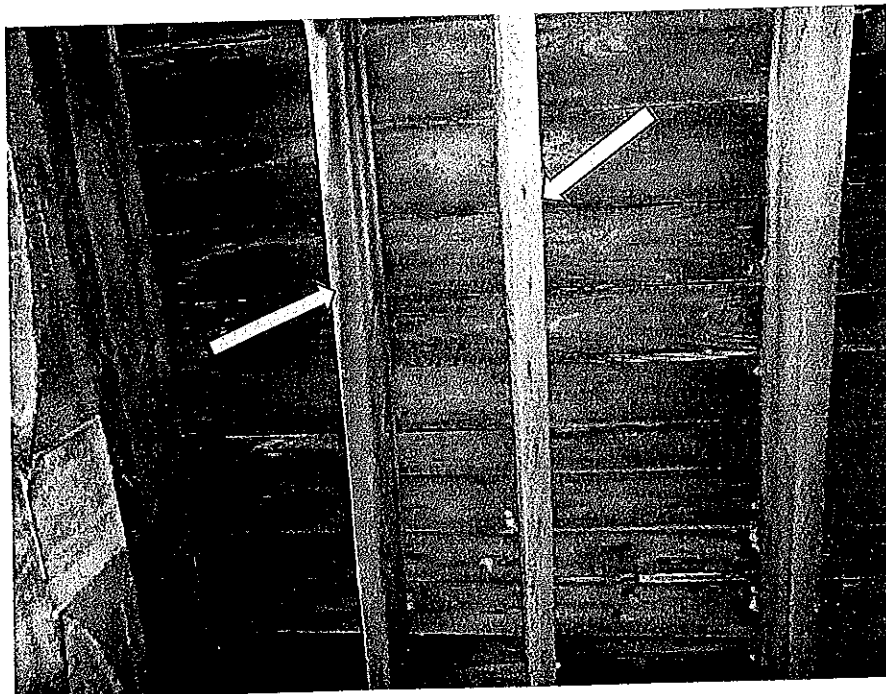
S48. Twisted wood floor joists in Clock Tower.

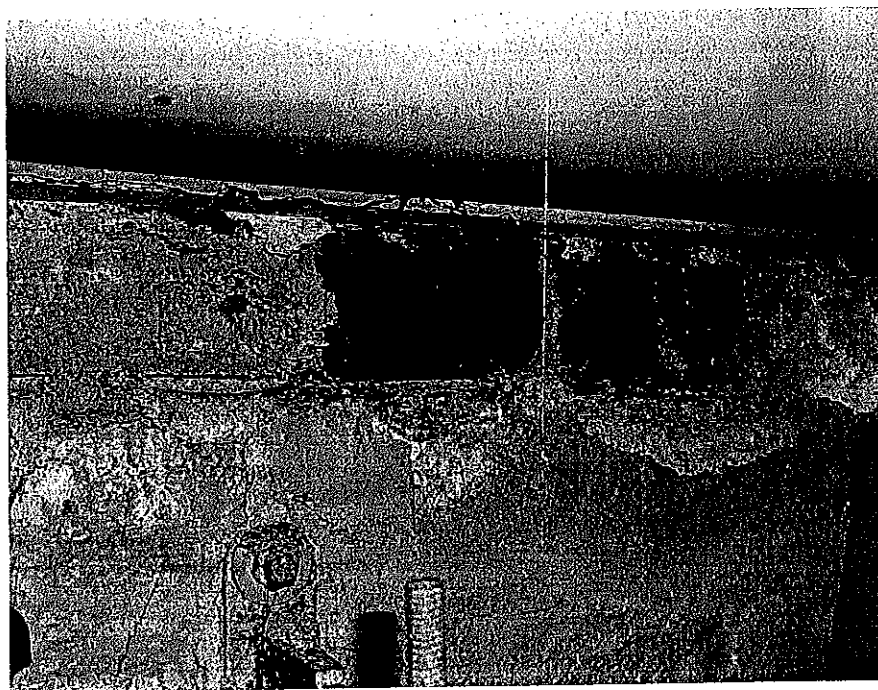
S53. Interior brick foundations at basement level showing loss of paint and plaster finishes and loss of mortar from mortar joints.

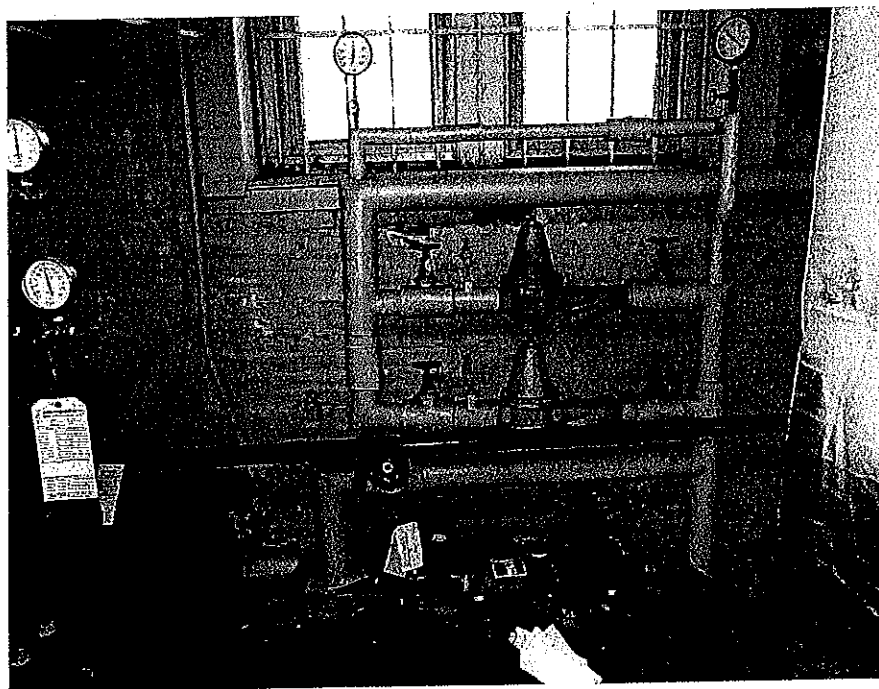
S54. Interior brick foundations at basement level showing loss of paint and plaster finishes and loss of mortar from mortar joints.

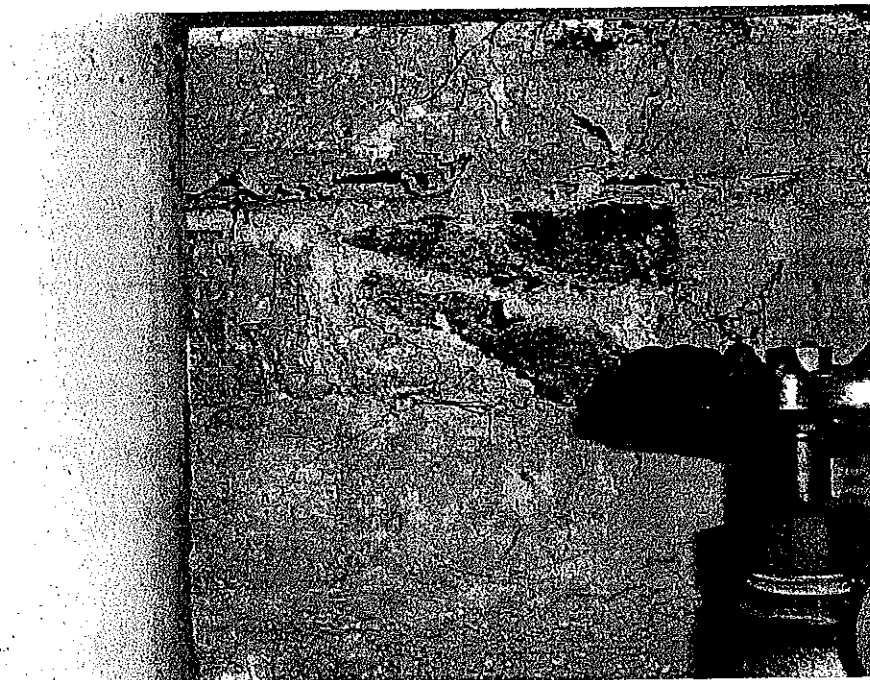
S56. Interior brick foundations at basement level showing efflorescence, loss of paint and plaster finishes and loss of mortar from mortar joints.

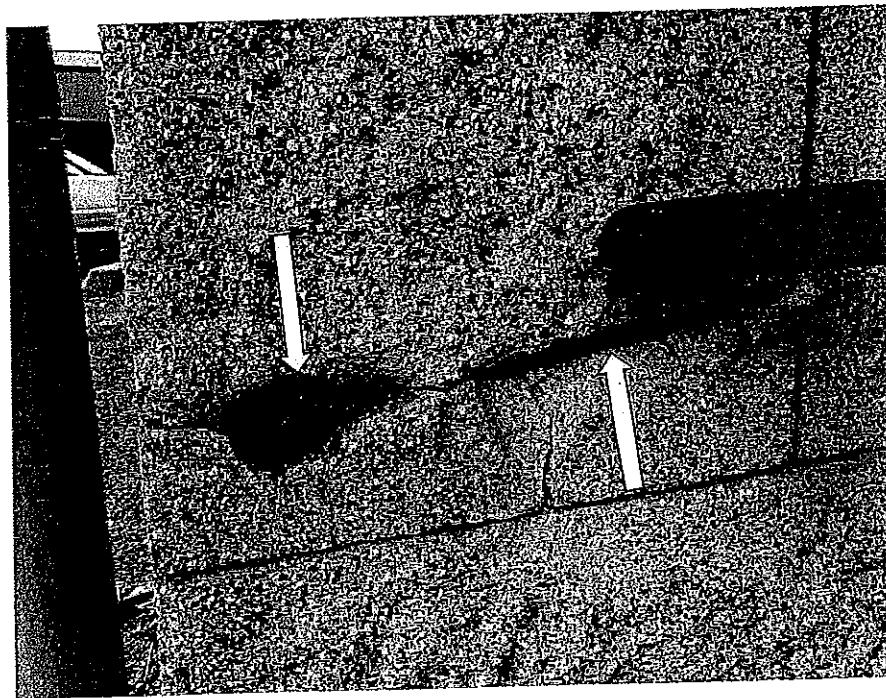
S60. Cracked cast stone block due to embedded iron rod at northeast corner of Annex.

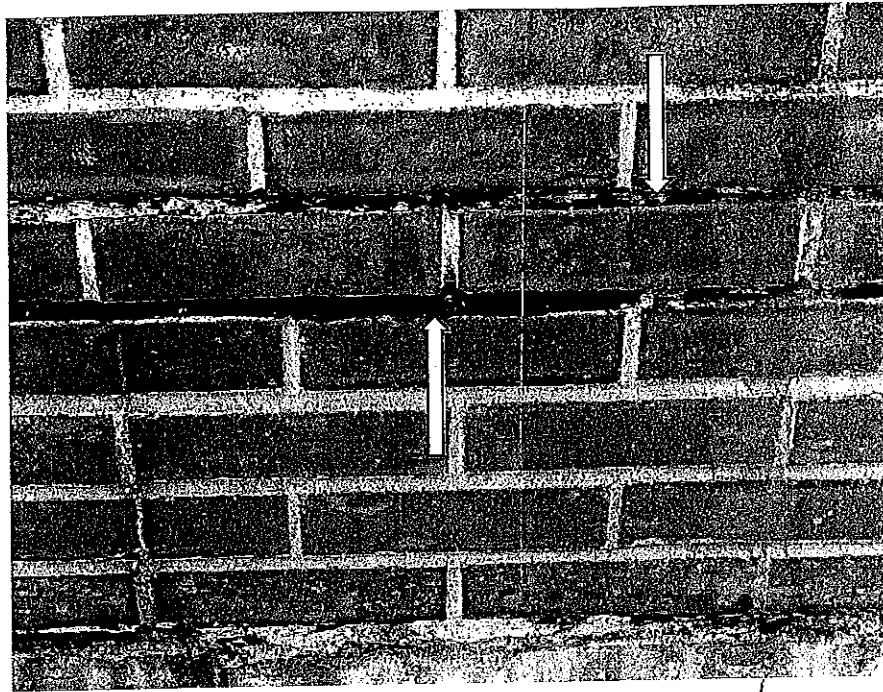
S61. Deteriorated mortar joints along north elevation of Annex Building.

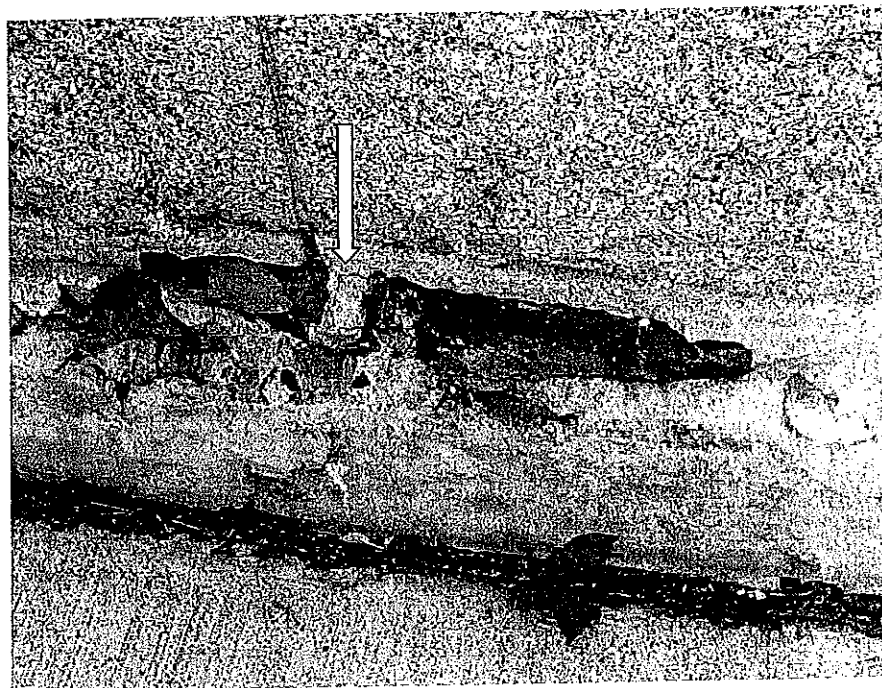
S62. Deteriorated mortar joints along north elevation of Annex Building.

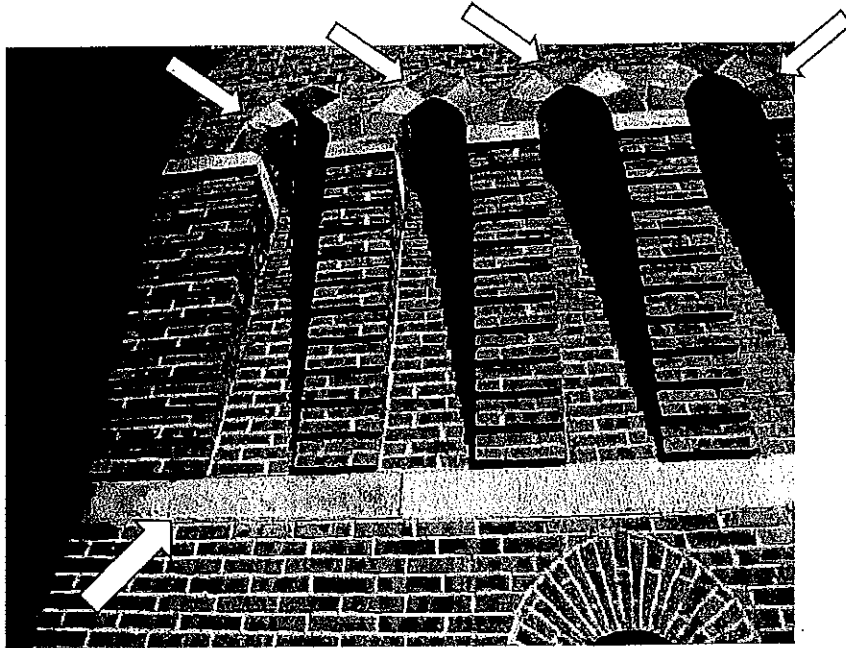
10. Photo 10—At the Tower, the stone banding below the brick corbelling is an example of a simple shape. Similar banding is on each elevation of the Old City Hall and Tower. At this location, the stone band below the corbelling exhibits flaking. The stone arches above the corbelling have deteriorated at numerous locations.

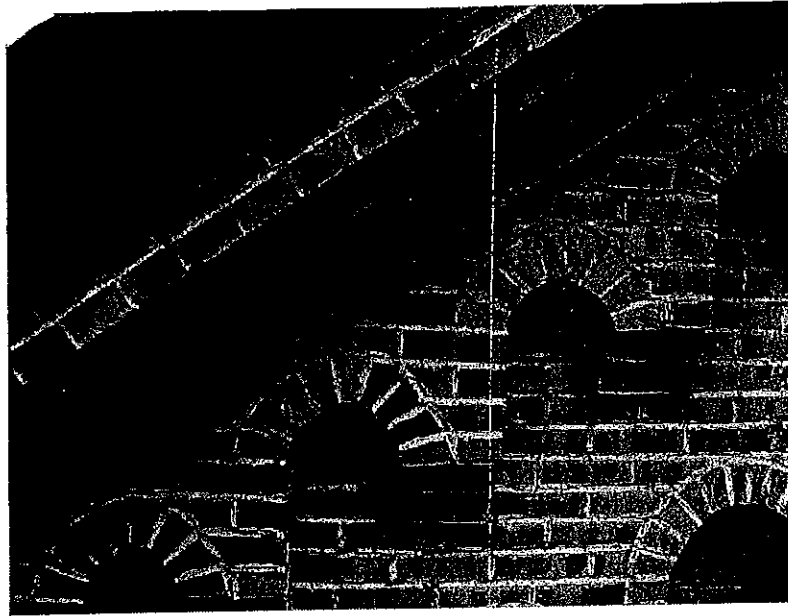
12. Photo 12 – View on the West elevation of the original black mortar observed within the brick corbels and dentils. This mortar was generally softer and sandier in these areas. Within the brick arches and in the field of the wall, the black mortar has bleached resulting in varying colors ranging from dark grey to bright white.

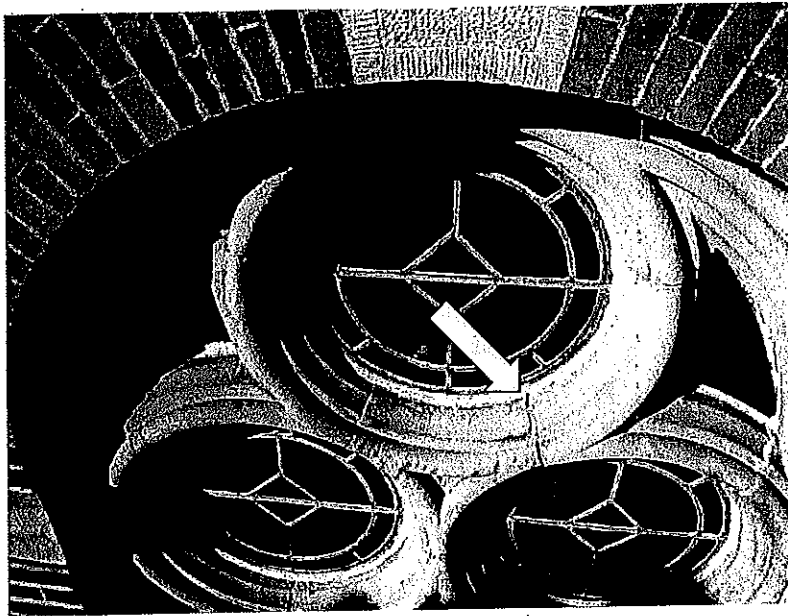
14. Photo 14 – An example of missing mortar within the stained glass window tracery on the South elevation.

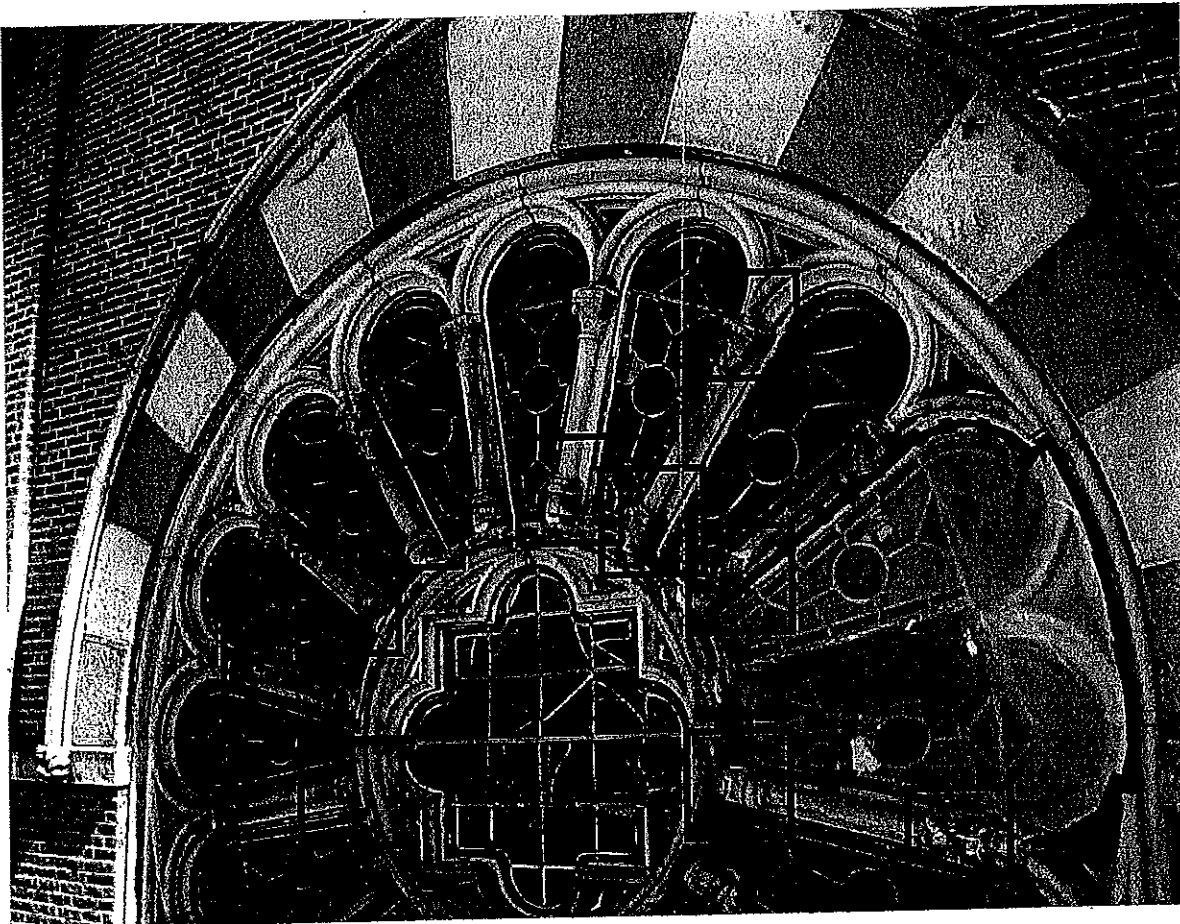
19. Photo 19 –Partial view of the rose window on the West elevation. The locations noted are where the stone has cracked, spalled, or become dislodged.

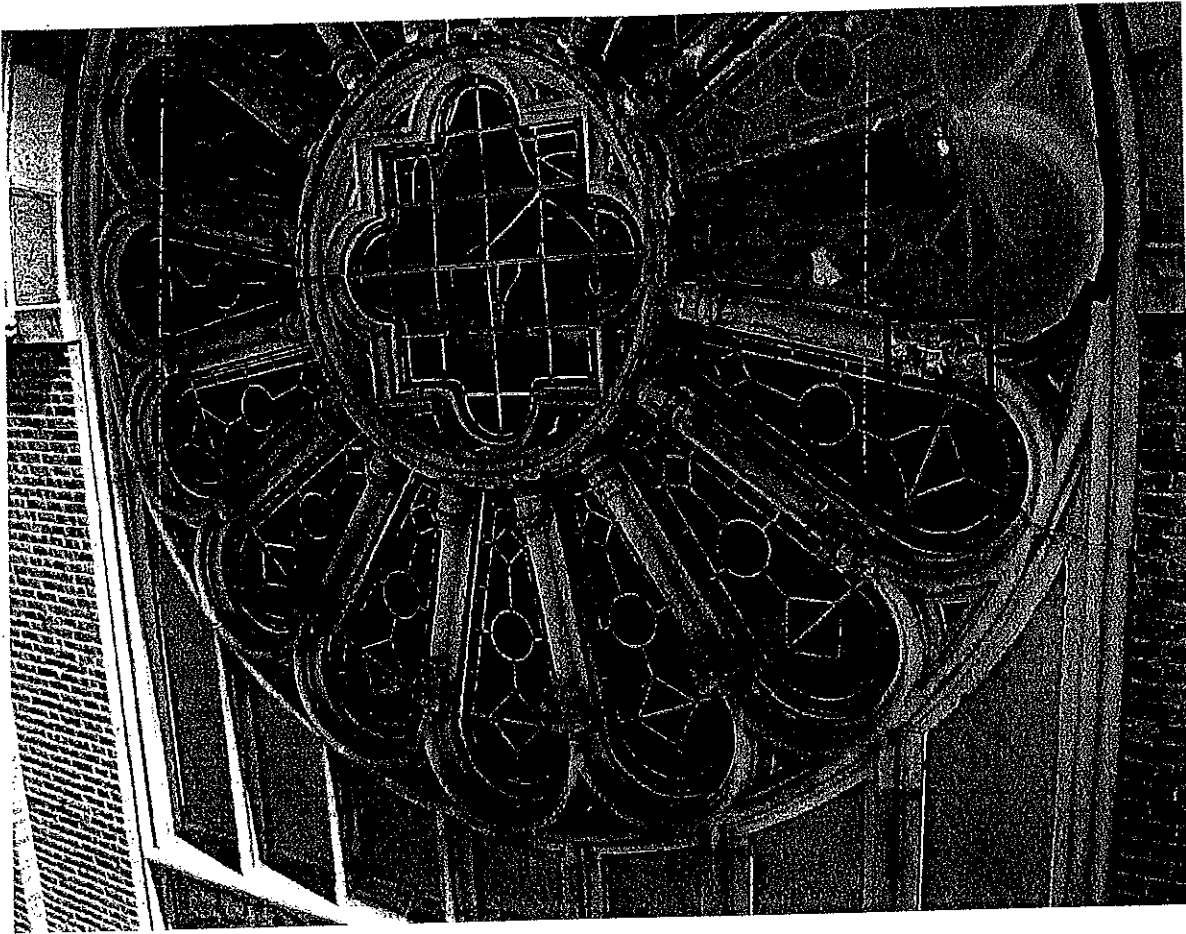
20. Photo 20 – Partial view of the rose window where the tracery has fallen out of the assembly. The locations noted are where the stone has cracked, spalled, or become dislodged.

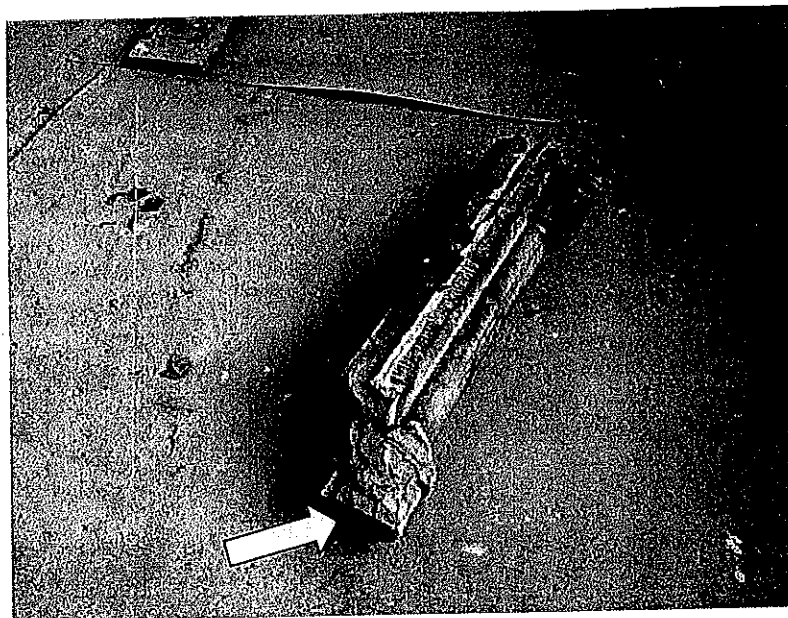
22. Photo 22 -- View of one of the rose window tracery spoke that has fallen out. The steel connection at one end is noted.

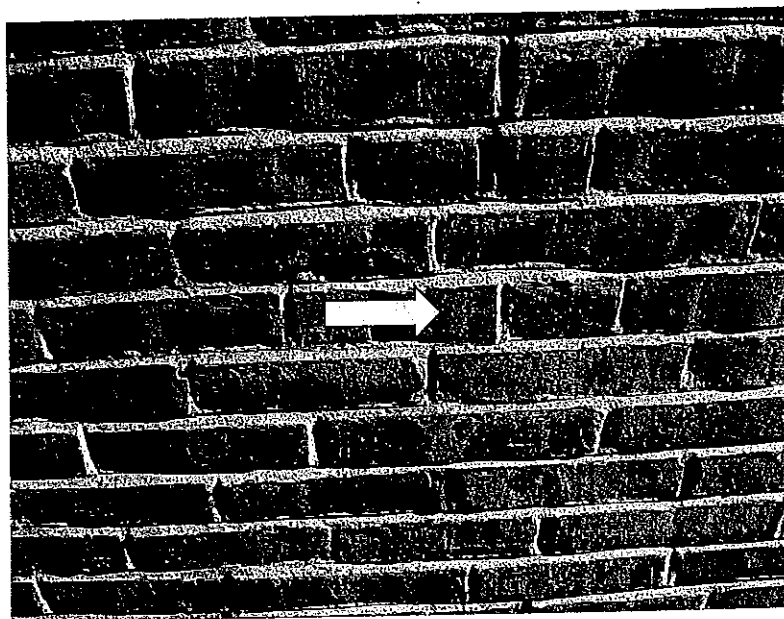
23. Photo 23 -- View of a cracked brick in the field of the wall on the South elevation of the Tower. Similar occurrences were observed on each elevation of the Old City Hall and the Annex.

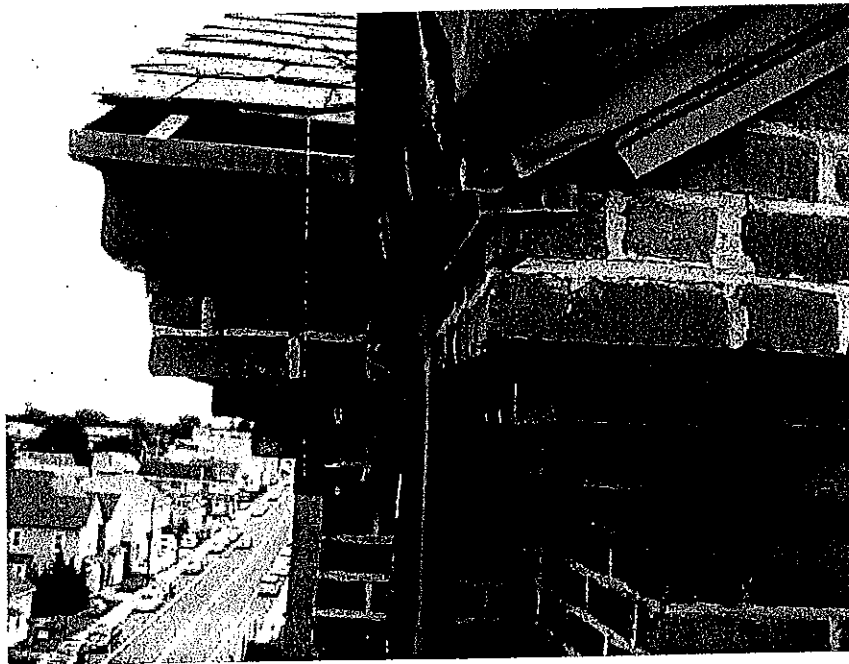
24. Photo 24 – View of the deflected brick corbel assembly at the Northwest corner. Note the open mortar joints and deflected brick.

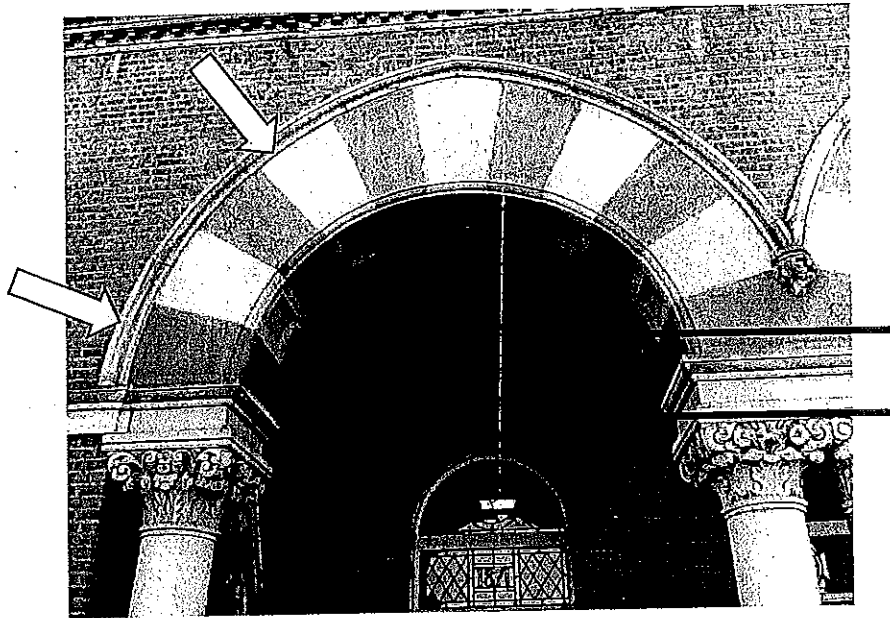
26. Photo 26 – The curved stone trim pieces on the Northern arch are cracked and have experienced surface crusting. The deteriorated stones should be replaced with new pieces that match the original. Similar deterioration was observed at the upper level stone arches. Also noted are the deteriorated stone trim above the column capitals have eroded.

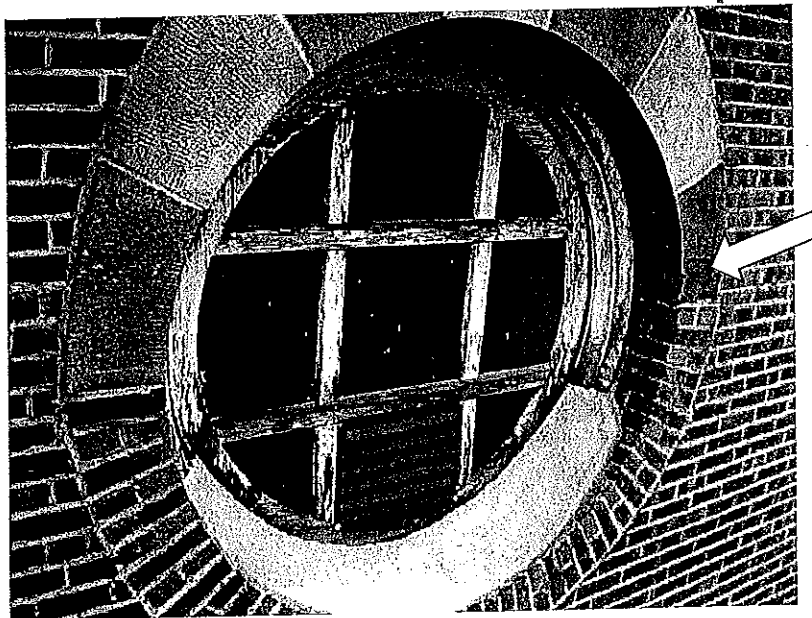
31. Photo 31 – On the West elevation, the flat stone arch has delaminated where noted. The paint on the wood window frame and brick mold trim has peeled exposing the wood to weather.
